LP BULLETIN

CHITTAGONG PORT GENERAL CARGO BERTHS- DRAFT AND FENDER ISSUES

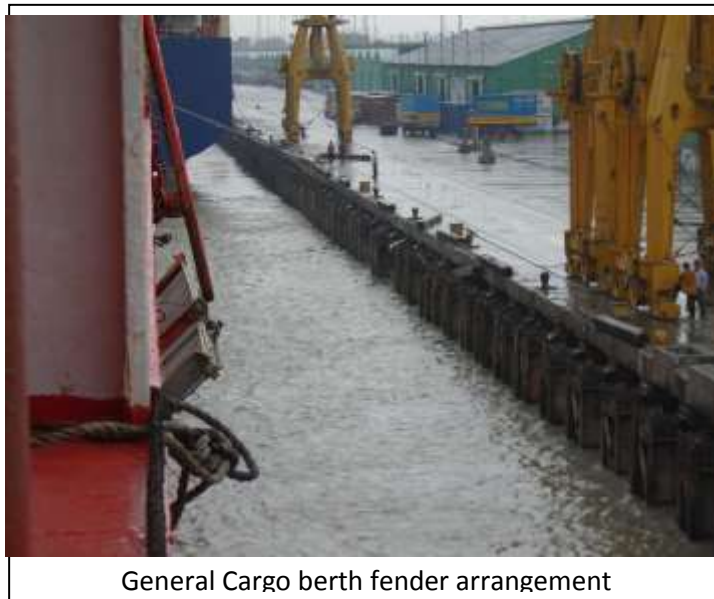
A more serious concern for ship safety are the condition of the GC berth fenders which are constructed as a composite structure of two vertical steel “I” connected by another transverse beam and supported by a rubber shock absorber connected to the pier. The flat faces of the steel “I” beams were clad with solid timber pieces to ensure that there would be no steel to steel contact between the ship’s hull and the steel “I” beams.

The timber claddings would also protect the ship’s hull from the sharp upper edge of the ‘I’ beams as vessels would move up and down with tide or during loading and unloading.

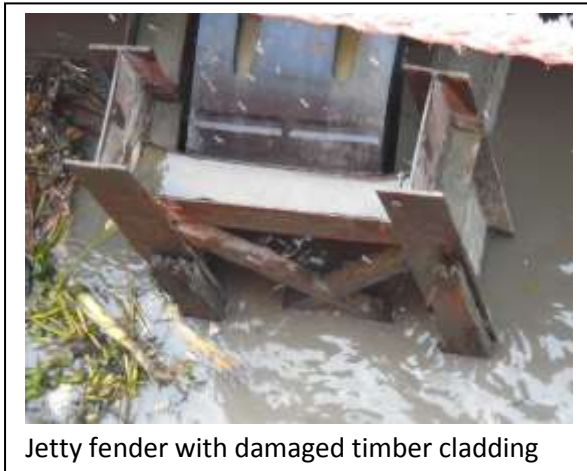
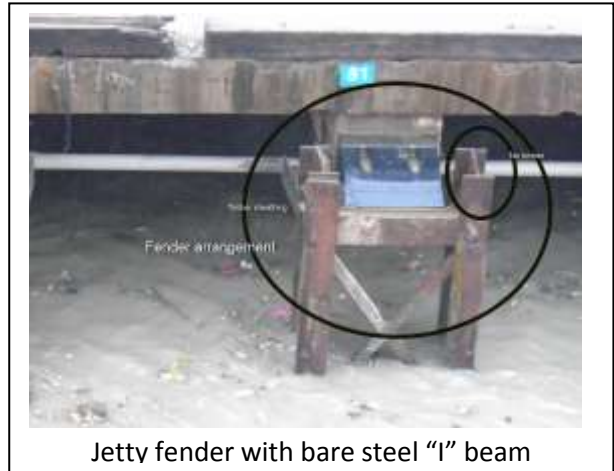
Owners and masters are to note that many of the jetty fenders are in poor state of maintenance. The timber protecting claddings are missing or broken on many fenders, leading the underlying steel “I” beams exposed for contact with the ship’s hull during berthing or during the period the vessel is alongside. This risk at berth is more for vessels having a jutting or protruding steel fender along the hull which may get caught by the upper edge of the steel “I” beam when the vessel falls with low water. Recently we have seen a vessel’s solid longitudinal half round steel fender to get caught by the upper edge of an exposed jetty fender during the ebb tide. This incident caused damage to both the jetty fender structure and the vessel.

This condition of the fenders exposes the vessel to risk of damage to hull and also to risk of claim from the port even when the fault lies solely with the port.

Mariners are advised to note the condition of the fenders and to take appropriate action during berthing and when alongside the pier. In the latter case tending/slackening mooring line may be needed to ensure that the hull is not pressed too tightly against the fender beams when there is a risk.
