## **Loss Prevention Bulletin - AVA/2014/0013**

### **FENDER DAMAGE AT RORO BERTH**

**Applicable to:** RoRo Vessels / Ports & Terminals  
**Region:** Vancouver, British Columbia  
**Category:** Loss Prevention

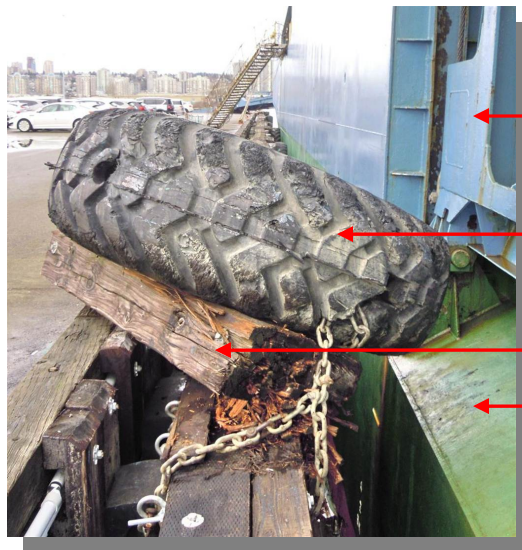
Midship Ramp

Tire Fender

Bull Rail

Ramp Recess

Enlarged View

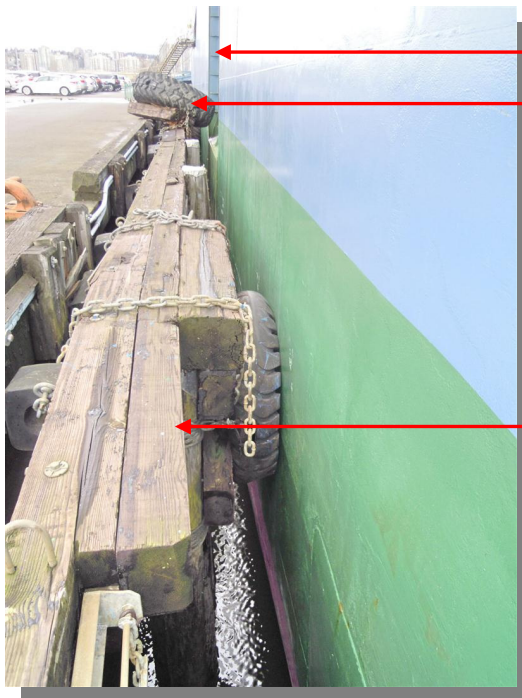
Midship Ramp

Damaged Fender

Bull Rail

For comparison -showing the original positioning of the fender in normal conditions
