LP BULLETIN

CHITTAGONG PORT GENERAL CARGO BERTHS- DRAFT AND FENDER ISSUES

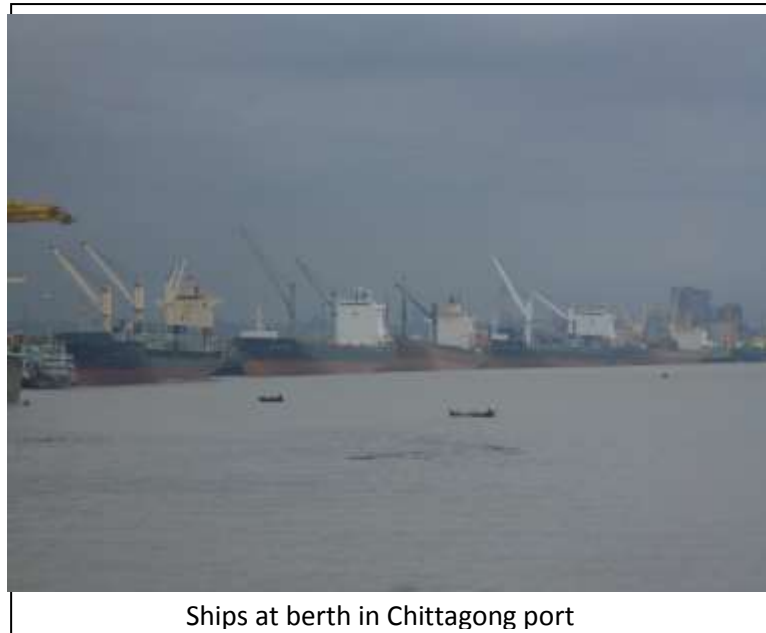
Chittagong is the principal sea port of Bangladesh and handles more than 90% of the country's export trade and 70% of import trade. The port has seen good expansion in the last twenty years with new container terminal built down river of the old port that was built in late 1880s. The old port was mainly handling general cargo vessels and had 13 berths numbering 1-13. The port now has the dedicated container berths under New Mooring Container Terminal and Chittagong Container Terminal. Because of congestion, a number of GC berths are also used for container handling. The GC berths have been re-assigned as numbers 2 to 13 with adjustment of berth lengths.
